**Re: Allegation of Jones Act/Safety/Pollution Violations: EPIC HEDRON**

# HEDRON DERRICK BARGE

## TRITON OFFSHORE

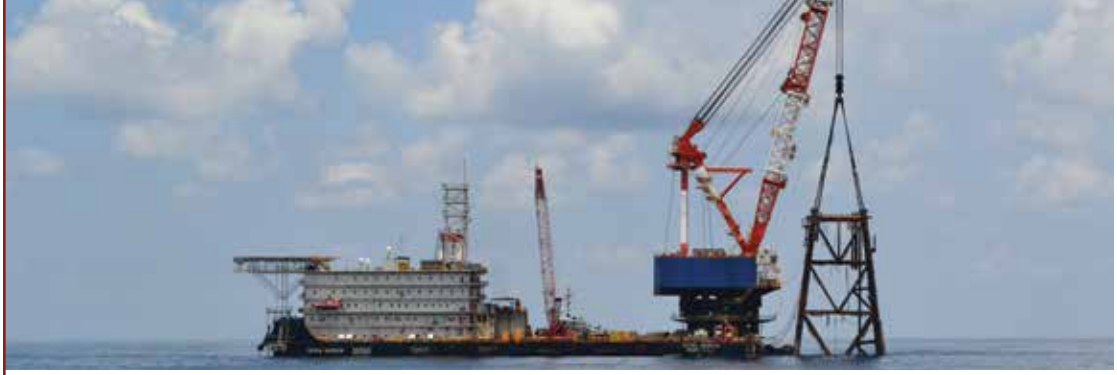
The DB Hedron is a world-class derrick barge with a 1,763-ton (1,600-metric) capacity, fully revolving crane, and accommodations for 300 personnel. The DB Hedron and its experienced crew offers valuable solutions for heavy lift, decommissioning, construction, and installation projects.

DIMENSIONS	
Length (LOA)	394 feet (120 meters)
Width	118 feet (36 meters)
Depth	31.5 feet (9.6 meters)
Operating Draft	19.7 feet (6 meters)
Working Deck Area	14,322 square feet (4,340 square meters)
Classifications	ABS A-1, CRC, Accomodation/ Work, UWILD Solas
Registry (Flag)	Vanuatu
Helideck	
Dimensions	83 x 77 feet (25 x 23 meters) capable of receiving a Sikorsky 61N
Load Capacity	28,660 pounds

<sup>4</sup> See EPIC HEDRON vessel specifications (attachment D).
